## MAPPING THE CORROSION POTENTIAL OF DOWEL BARS

A main A-Road in the east of England was constructed with un-reinforced concrete slabs joined with dowel bars. Visual deterioration to the surface caused concern about the condition of the dowel bars.

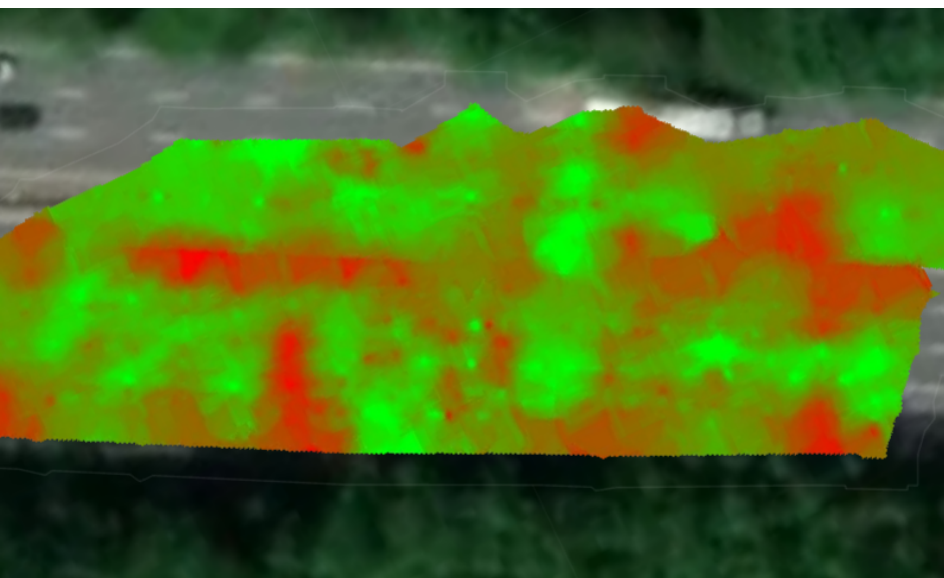
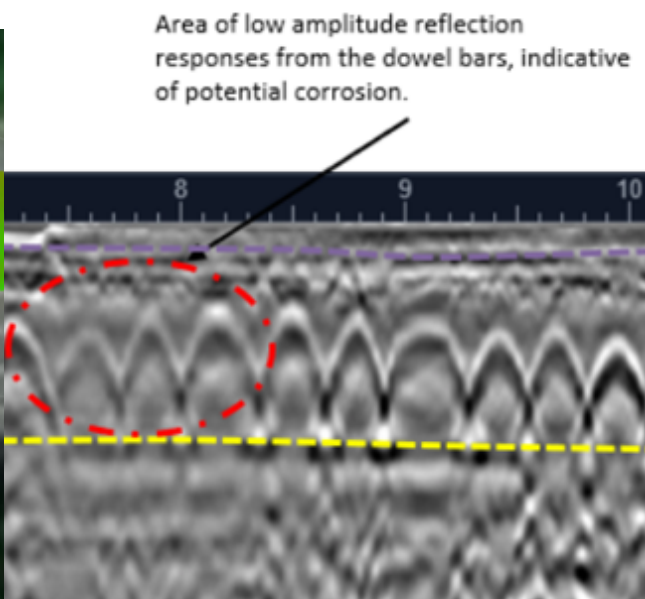
Area of low amplitude reflection responses from the dowel bars, indicative of potential corrosion.
