INVESTIGATION INTO THE CAUSE OF KNOWN DEFECTS

A section of the slab was presenting with significant heave, the cause of which was unknown

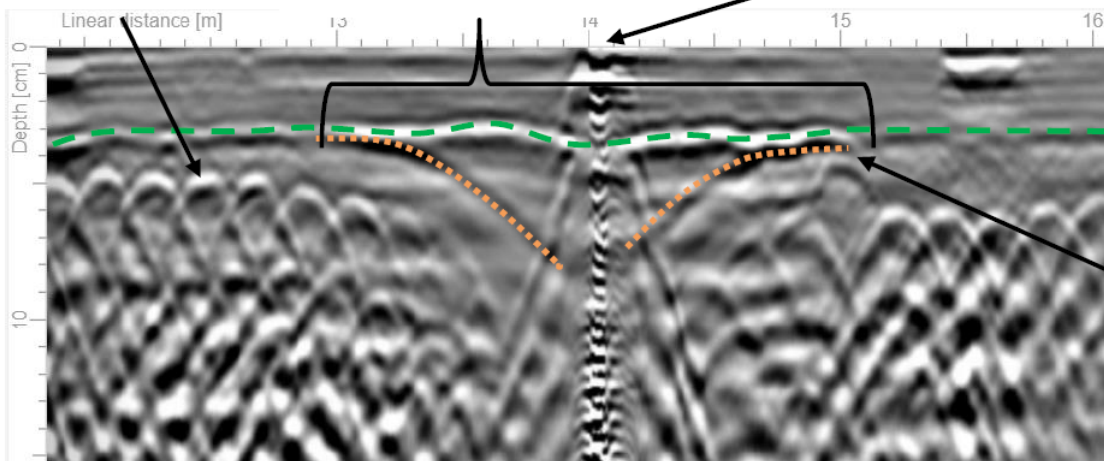
Trace-SI analysed the data off site and were able to determine the typical construction details of the slab and where they varied around the defect. It was found that, while voiding was detected below the slab, only the surface finishes were rising up.

Furthermore, the gap between the slab and the surface finishes was filled with water. Water had penetrated through the surface finishes and likely caused corrosion to the steel within the concrete slab, resulting in expansion of material

Slab reinforcement at 200mm centres at ~150mm depth

Strong reflection amplitude, indicative of a water filled cavity.

Gully

Underside of screed/surface finishes at ~80mm depth.

Apparent top of the structural slab, thought to be level but visually increasing in depth due to the presence of a cavity above.
